Tamboti Tented Camp – Access for Guests with Mobility Challenges

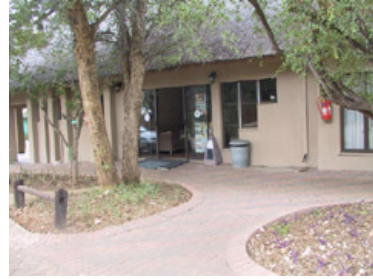
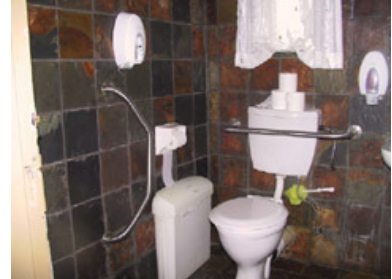
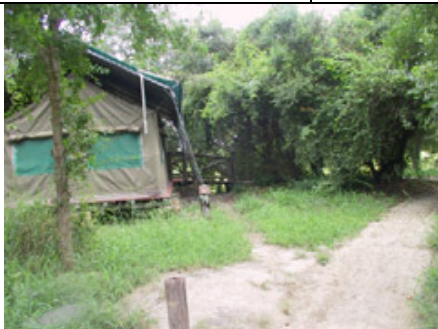
Visitors with reserved accommodation in Tamboti must first check in at the reception at Orpen Camp. Here there is a ramped entrance and a wheelchair ablution (where the grab rail on the adjacent wall needs repositioned!).

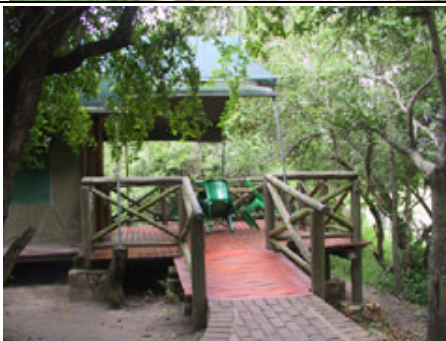
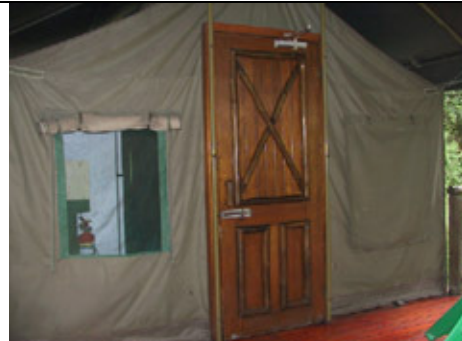
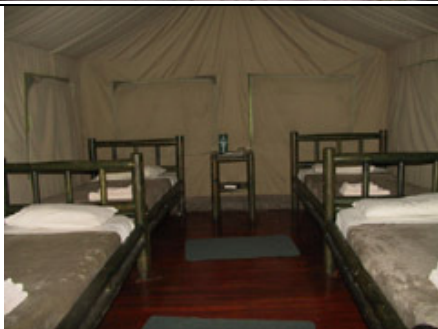
The 2 **accessible tents with communal ablutions** are identical except that one has 4 beds and the other only 2. There is a bit of soft sand to negotiate from the parking area in front of these units, but then the path is wide and bricked, while the access to the units’ decks are ramped.

Although the beds are quite low in these units, there is plenty of space for manoeuvring inside of the tents.

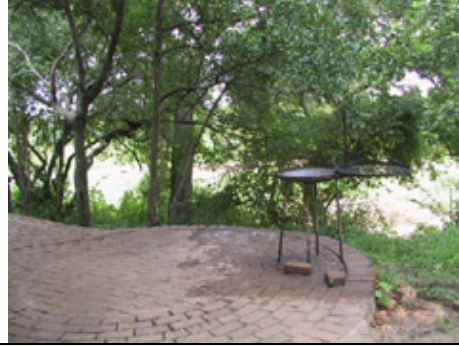
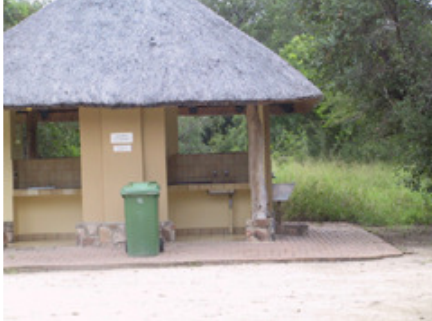
Each unit has its own braai (barbecue) facility for cooking on an open fire. The ones in the accessible units have been made accessible from all sides

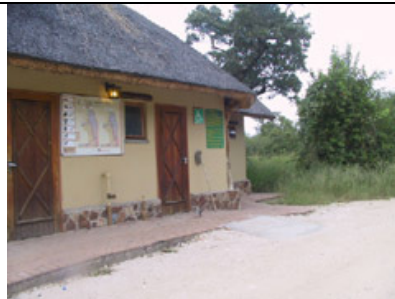
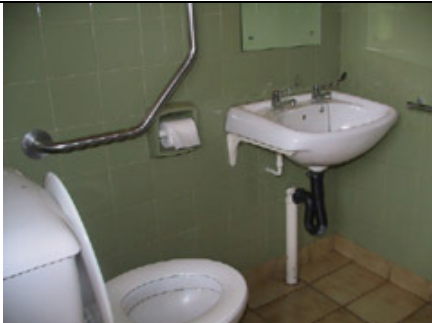
The communal washing up facility (with hot-plates for cooking) is located about 20m from the accessible units. There is a small step (about 5cm from the ground up to the paved area) caused by rainfall erosion, but most wheelchair users should be able to negotiate this with ease.

The communal ablution block where the wheelchair accessible toilet and shower is located is perhaps 30m from the units. The earth has been built up to the paved level where the heavy summer rains had created a step.

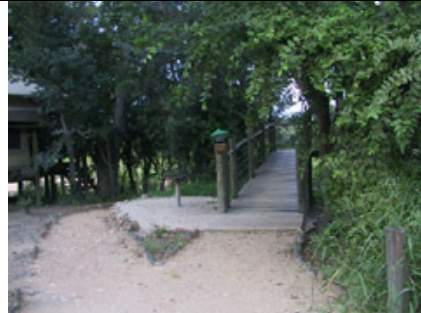
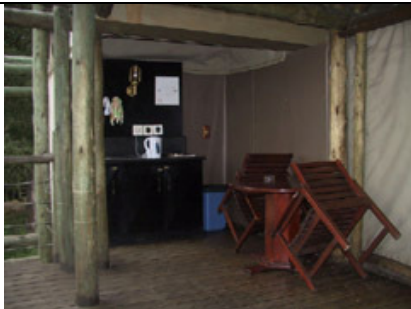
The ramp from the parking area is not too steep and the gravel from the parking to the ramp is compact, making mobility in a wheelchair easy. Heavy rain has meant a slight step from the gravel up to the concrete base of the unit. The braai (barbecue) facility is at the base of the ramp to the left of the image.

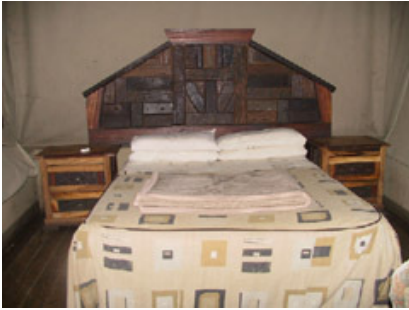
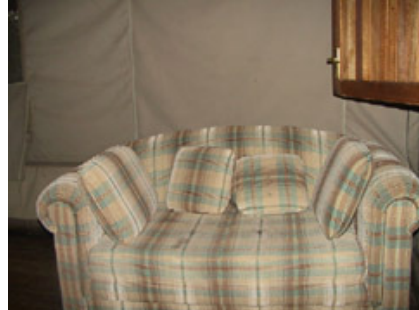
The door to the interior is spring loaded to help keep out the monkeys and baboons. It is however wide enough for wheelchair passage. Inside the unit is less spacious than the communal tents. There is one double bed, with bedside cabinets and just enough space for a wheelchair to pass between the side of the bed and the wall of the tent. Much of the bedroom interior space is taken by the sleeper couch.

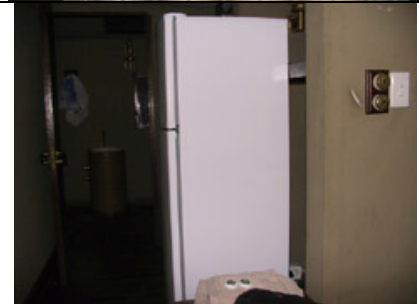
Baboons have proved to be a big problem at Tamboti and as a result all fridges are kept indoors and the units are provided with keys and locks. This creates a space issue as it is positioned in the passage from the bedroom to the bathroom. However there is just enough space to get past in a wheelchair to get to the bathroom.

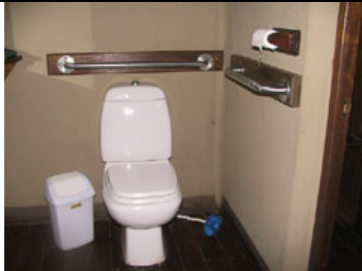
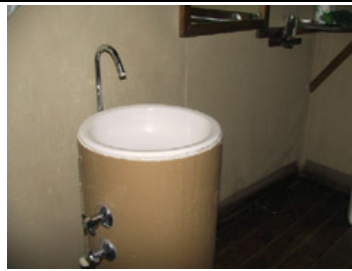
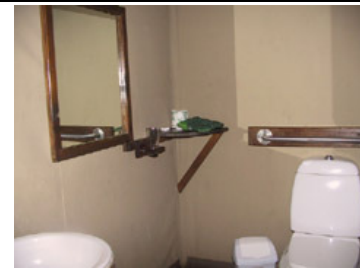
The unit's ablutions are not well designed and there are several factors that are not in keeping with a properly accessible unit. The toilet itself is fine and is equipped with grab rails adjacent and behind the toilet, but the water basin is out of reach of a person sitting on the unit. The design of the basin is also not suited for a person in a wheelchair as they cannot position their chair underneath the basin. Also the taps are not suitable for persons with a cervical injury with limited hand control as there are standard turn taps. The taps are also positioned in a very awkward position for a person in a wheelchair. Then the position of the basin is in an awkward position in relation to the basin, being off to the side. This makes shaving or other acts of grooming ungainly for all occupants.

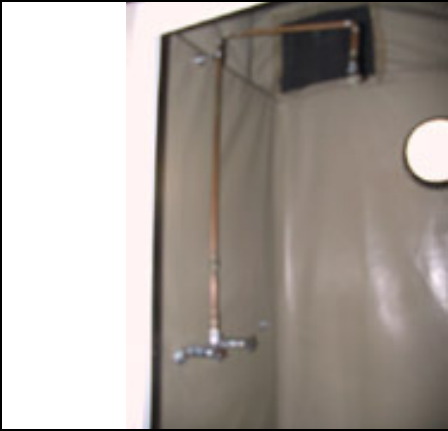
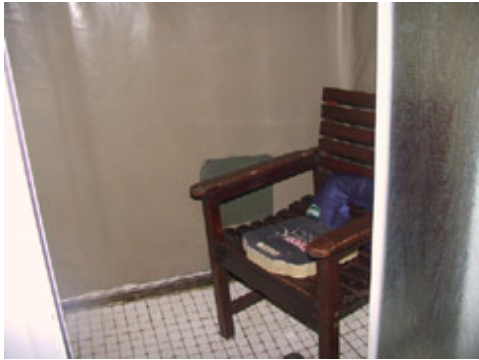
But the biggest problem with the unit's ablutions from an access perspective is with the roll-in shower. There is no step or curb into the shower cubicle, but there is no detachable handset on a height adjustable sliding pole, so a wheelchair user cannot position the spout at an appropriate position, nor remove the handset to properly wash the immobile parts of their body. There is no push style mixer for people with limited grasping ability to turn the flow on and off. Then there is no fixed fold down seat for transfer out of one's wheelchair when showering. I got round this failing by dragging one of the chairs from the deck into the shower, but this is far from ideal and the camp management needs to address these situations urgently. If the dry walls of the shower are not strong enough to support a shower seat and a person sitting on it then mobile shower seats should be provided.
